Special Inspection Daily Report

Client: HC Contractors Project: King Salmon

Contact: Shelby/Thomas Type of Inspection: Section 32 13 14.13

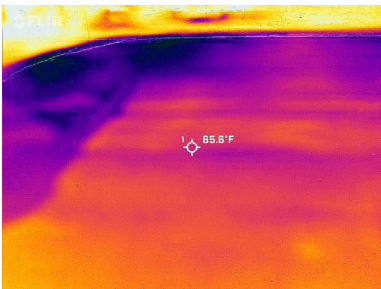
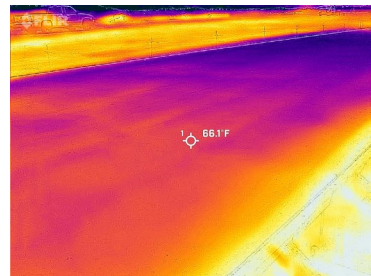
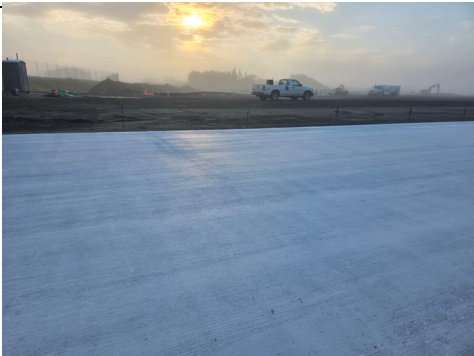
Left & Bottom Left: 22 June 2026, 1645, hours at 8 hours and 10 minutes after placement start, not sufficiently hardened. Thermal imaging consistent concrete temperatures. Please See Evaporation Control Chart  
Right: 23 June 2026, 0634 after placement start, not sufficiently hardened for sawing operations

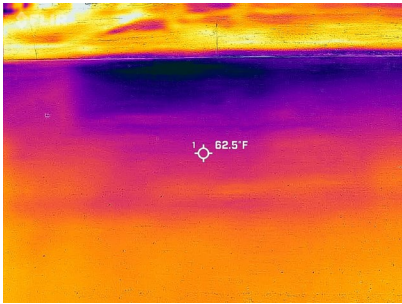
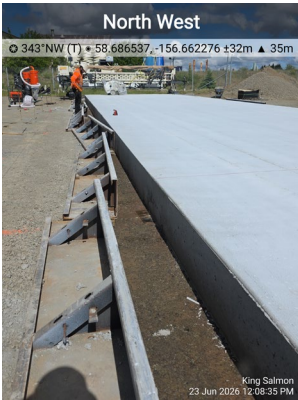
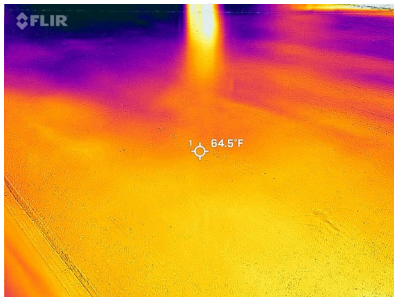
Top Left & Bottom Left: 23 June 2026 0941 hours, 18 hrs. and 21 minutes elapsed grade, temperature 52°F with Partly sunny skies  
Right: Forms removed, 23 June 26 at 1208 hours, 27 hrs. and 18minutes elapsed, note moisture still present under forms.  
Right: Dust collection system for concrete dust particulates and debris from initial joint saw cuts

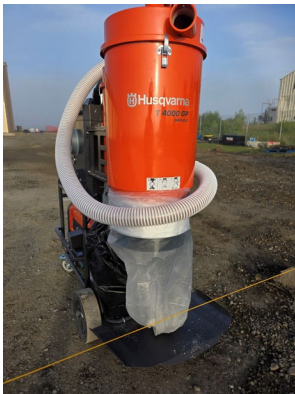
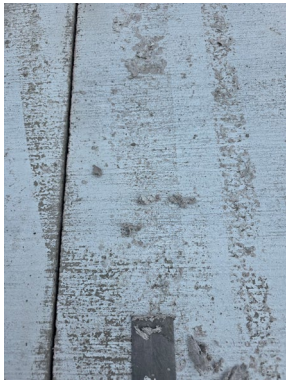
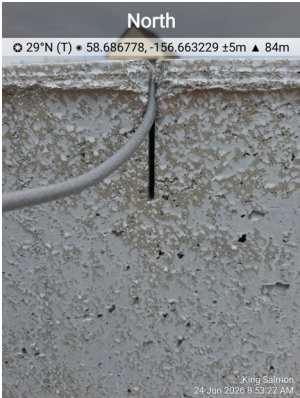
Bottom Left: 28hrs. elapsed, finish of initial joint saw cut, cure gummy and sticking to wheels of Husqvarna Soft Cut Saw, ¼” ± of cure material scraped off concrete horizontal surface  
Bottom Right: 24 June 26 at 0853 hours, 19hrs. 35minutes elapsed form initial saw cutting operation, no propagation of crack noted at joint groove at exposed edge. Light rain at 11am on 24 June 2026, delayed respray of curing compound

| Respray of curing compound | Cure Compound, W.R. Meadows 1640 white, tacky after 28 hrs. ±<br>Curing Compound applied before evaporation of free water from horizontal PCC surface and not applied evenly over joint face and vertical face of concrete |
| | Early entry saw blade, soft for aggregate hardness, snapping of line at the end, creating curl and ¼” deviation in joint saw cut |
